## ADVANCED ANALYSIS OF BACKSHEET FAILURES FROM 26 POWER PLANTS

J. Markert, S. Kotterer, D. E. Mansour, D. Philipp, P. Gebhardt  
Fraunhofer Institute for Solar Energy Systems ISE  
Heidenhofstr. 2, 79110 Freiburg, Germany

**Keywords:** PV Modules, Backsheet Degradation, Scanning Acoustic Microscopy, Insulation Failure Analysis

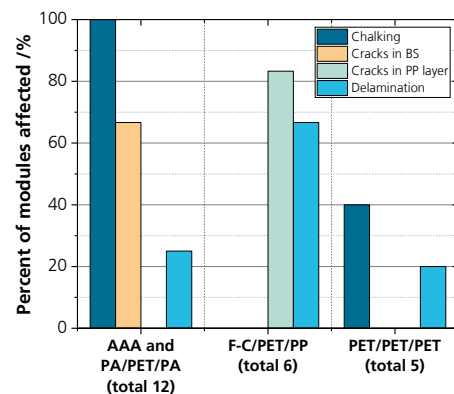
**Figure 2:** Distribution of the failures in the most relevant degraded backsheet structures after several years of operation.

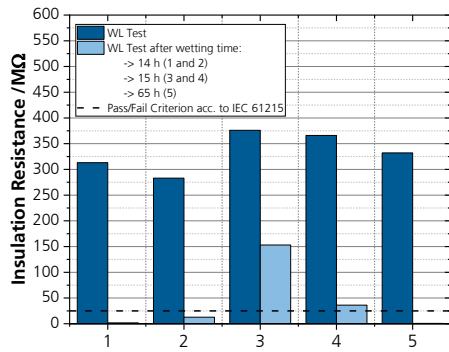
**Figure 3:** Wet leakage current test results of five exemplary modules from two power plants that have been measured initially and after extended wetting times: 15 h, 65 h and 14 h.

Five additional modules that passed the first WL test were subjected to an extended wetting time in a water bath for 14 h, 15 h and 65 h, respectively, before the WL test was applied for a second time. This was done in order to reproduce low insulation resistance values that had been observed in the field and had led to inverter outages. All five modules used the same backsheets foil: F-C/PET/PP. The measurements showed a strong decrease of the insulation resistance values in the modules after the extended wetting time (Figure 3), which coincides well with the observed inverter outages. This suggests that an increased wetting time beyond the test conditions according to IEC 61215-2:2016 (MQT 15) can be required to detect low insulation properties that lead to inverter outages.

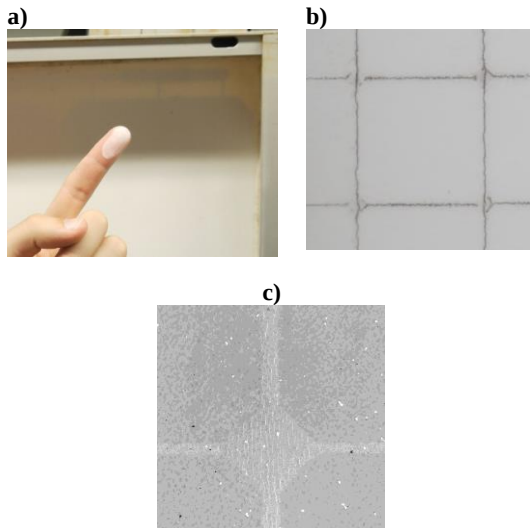
**Figure 4:** Images from different degradation features; a) Chalking on rear side of a polyamide backsheets [10]; b) Cracked AAA backsheets; c) Small cracks, indicating a damaged PP layer in a F-C/PET/PP backsheets.

All modules with polyamide backsheets (AAA and PA/PET/PA) as well as 40 % of the PET based backsheets deposited a white powder (Figure 4 (a)), known as chalking [10], on the rear surface after field exposure. 67 % of the investigated backsheets with polyamide developed cracks Figure 4 (b), typically in the cell gaps, suggesting a degradation mechanism initiated by front side UV radiation [3], or along the cell connectors, indicating the appearance of thermo-mechanical stresses in these regions. The PET based foils, on the other hand, showed no visual defects besides chalking and insulation issues have reported from one module only. This suggests that there might be a connection between chalking and the formation of backsheets cracks in polyamide layer structures. Furthermore, it has been demonstrated that, moisture inside the polymer plays a synergistic role with UV in the formation of backsheets cracking [11][12]. Backsheet chalking can therefore be evaluated as an early warning sign that indicates an elevated probability for the

presence of a critical material and possible crack development in the future.

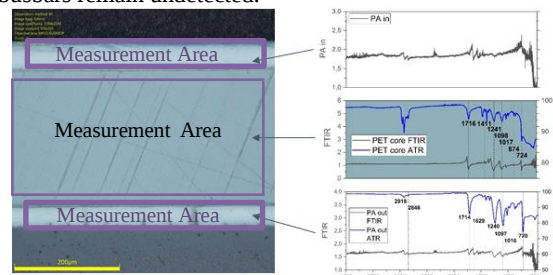
**Figure 5:** Left: Microscopy image of the multilayer PA/PET/PA backsheets cross-section in a PV module. Right: Comparison of FTIR microscopy spectra (black) of cross-section samples and ATR-FTIR

spectroscopy spectra (blue) of separated backsheet surface layers.

The FTIR microscopy has the advantage over ATR spectroscopy that it can be used to select a very small measurement area. There is no need to scrape off the outer layer to measure the core of the backsheets, since a cross-section is used for the measurement. To obtain a suitable signal to noise ratio for the used device, a layer thickness above 100  $\mu\text{m}$  is recommended. The PET layer, which can be found in the core of the backsheet in the left image of Figure 5, is shown in a comparison of the FTIR-ATR spectrum with the FTIR-microscope spectrum. As indicated by the vertical markers, all significant peaks of the FTIR-ATR spectrum can also be observed in the FTIR spectrum of the PET layer.

The spectrum of the outer layer of the APA backsheet, despite the noisier signal is sufficient for a qualitative statement: The FTIR-microscope spectrum has five peaks that coincide well with the FTIR-ATR spectrum: Peaks at 1097  $\text{cm}^{-1}$ , 1240  $\text{cm}^{-1}$ , 1719  $\text{cm}^{-1}$ , 2846  $\text{cm}^{-1}$  and 2918  $\text{cm}^{-1}$ .

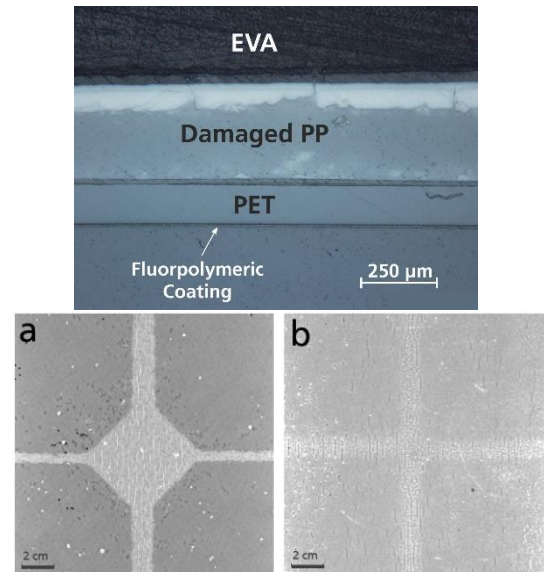
Hidden damages in the inner PP layer were found in F-C/PET/PP structures, despite a regular outer appearance of the backsheets. Cross-sectional images (Figure 6, left) revealed severe damage in the cell gaps within the backsheets in more than 80 % of the investigated modules with this backsheets type. The location between the cell gaps indicates one more time a degradation mechanism due to UV radiation. Illumination of the modules from the front side, sometimes referred to as “flashlight test” was found to be a straightforward and cheap method to identify affected modules. This can be done with a flashlight, shining through the backsheets in the cell gaps. On the rear side, the shadows of the tiny cracks in the PP layer become visible, similar to the image taken of an affected backsheets with a scanning acoustic microscope in Figure 4 (c). This method can serve as a first indication of cracks inside the layer structure. A clear disadvantage of this method is that only the cell gaps can be analyzed and cracks along the busbars remain undetected.

As another analysis technique, scanning acoustic microscopy was used to uncover backsheet cracking in specific layers non-destructively [11]. Figure 6 right (a and b) presents acoustic micrographs obtained from different time of flight (TOF) ranges inside the multilayered backsheets.

**Figure 6:** Top: Cross section of a F-C/PET/PP coating with damaged PP layer. Bottom: Acoustic images of the multilayer backsheets in a field-exposed PV module; (a) core/inner layers interface of F-C/PET/PP backsheet; (b) outer/core layers interface of PA/PET/PA backsheet.

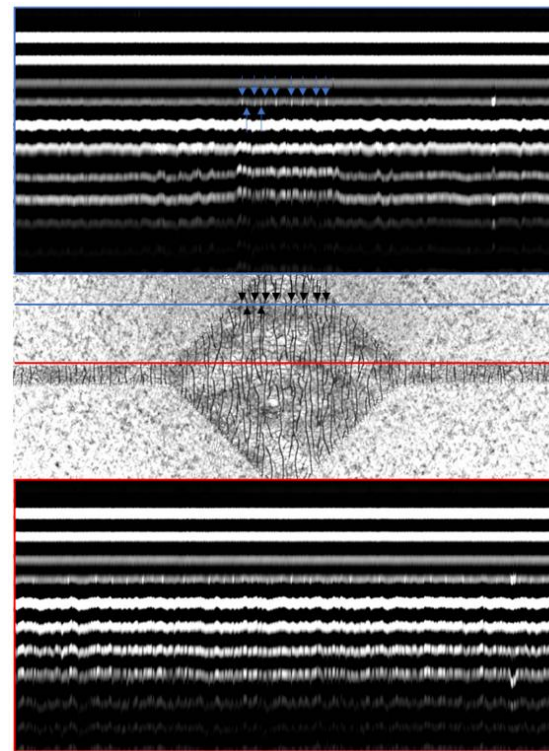
**Figure 7:** Acoustic cross-sections of a module with F-C/PET/PP backsheet revealing internal cracks (top and bottom), taken at the lines indicated in the micrograph (middle).

In order to validate the visualization of the location of these cracks and the depth profile of the PV module, acoustic line-scans along two different positions were executed, as presented in Figure 7 for a module with F-C/PET/PP backsheet and in Figure 8 for the module with APA backsheet. The corresponding backsheet cracks in the upper lines are marked with arrows for the comparison

The acoustic cross-sections confirm the same crack positions within the layer stack of the different modules. For modules with F-C/PET/PP backsheets, the cracks are visible at the 4th interface starting from the top line, which means at the backsheets inner/EVA layer interface. This coincides well with the results of optical microscopy (destructive) of the same material (Figure 6, left). For the module with APA backsheets, the cracks appear slightly earlier at the 2nd interface, i.e. the outer PA/core PET layer interface. This coincides well with the results of optical microscopy (destructive) of the same material (Figure 5, left), whereas, for the module with APA backsheets, the cracks appear slightly earlier at the 2nd interface, i.e. the outer PA/core PET layers interface.

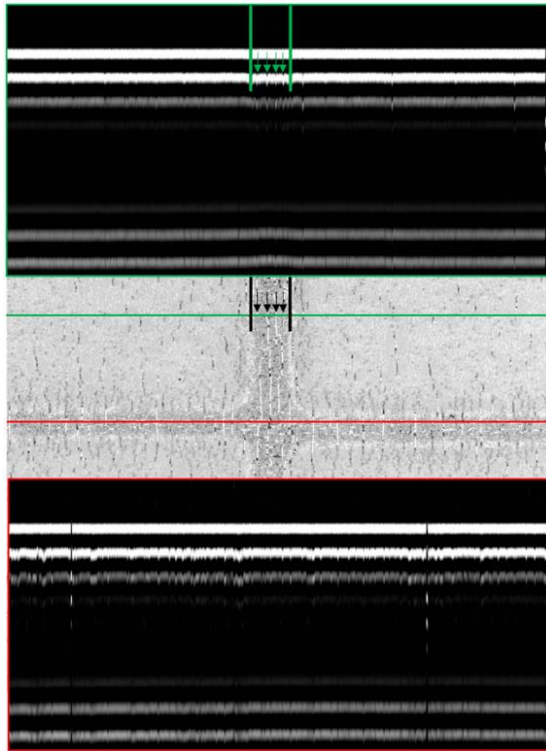
**Figure 8:** Acoustic cross-sections of a module with PA/PET/PA backsheets with polyamide outer layer cracking (top and bottom), taken at the lines indicated in the micrograph (middle).
